HANCOCK WOODS SITE ANALYSIS

BOSTON CONSERVATION COMMISSION
MARCH 1976

This report was prepared by
Shary Page Berg
Massachusetts Audubon Society Intern

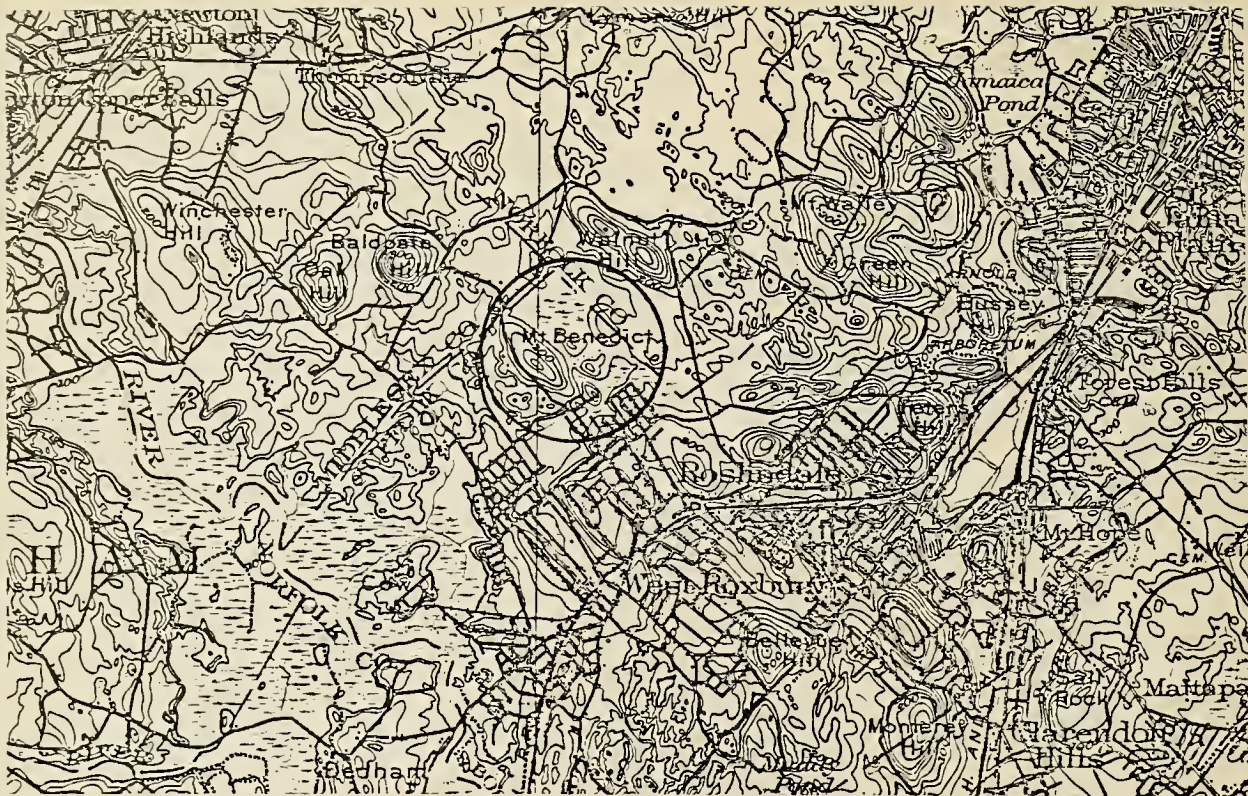
TOPOGRAPHIC CHANGE

1905

1970

Maps One through Five in this report include information from several different sources with varying levels of accuracy. The primary source was the City of Boston Topographic and Planimetric Survey (1965) at 1"=100' and 1"=200' with five foot contour interval. In areas outside the City of Boston the 1970 U.S.G.S. quadrangle at 1"=2000' with ten foot contour interval was the primary source. For changes occurring since 1965, air photos taken in 1969 and site plans of individual projects were used. These changes include new buildings at Chestnut Hill Park and Broadlawn Park, landfill associated with these two developments and the addition of a fire road in the Hoard Bird Sanctuary. In areas where changes have occurred, a dotted contour line is used to indicate that accurate contour information is not available.

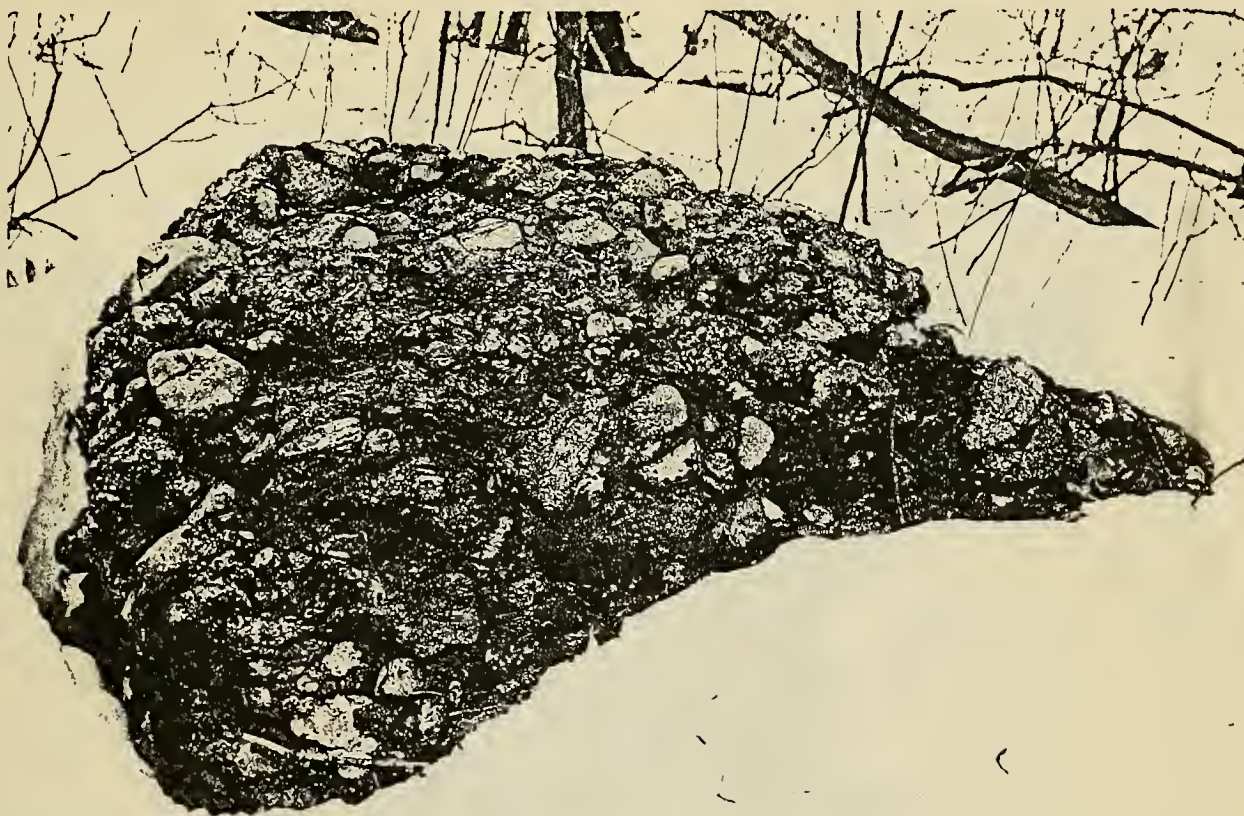
ROXBURY CONGLOMERATE - CLOSE UP.

with frequent outcrops occurring. Such is the case in Hancock Woods where Roxbury Conglomerate, also known as Roxbury Puddingstone, is exposed 10-20 feet above the surrounding area in places. The topography indicates that the base of the outcrops is masked by thin layers of fine textured soil which is interspersed with cobbles and pebbles, "raisins" from the puddingstone. Cracks and fractures illustrate the weathering of the exposed rock which is ideal for climbing and exploring. Construction in areas with surficial rock is extremely expensive but can be done if economic conditions warrant it. A good example is the adjacent John Hancock Village where buildings have been carefully sited to variety and utilizing rock outcrops as landscape features.

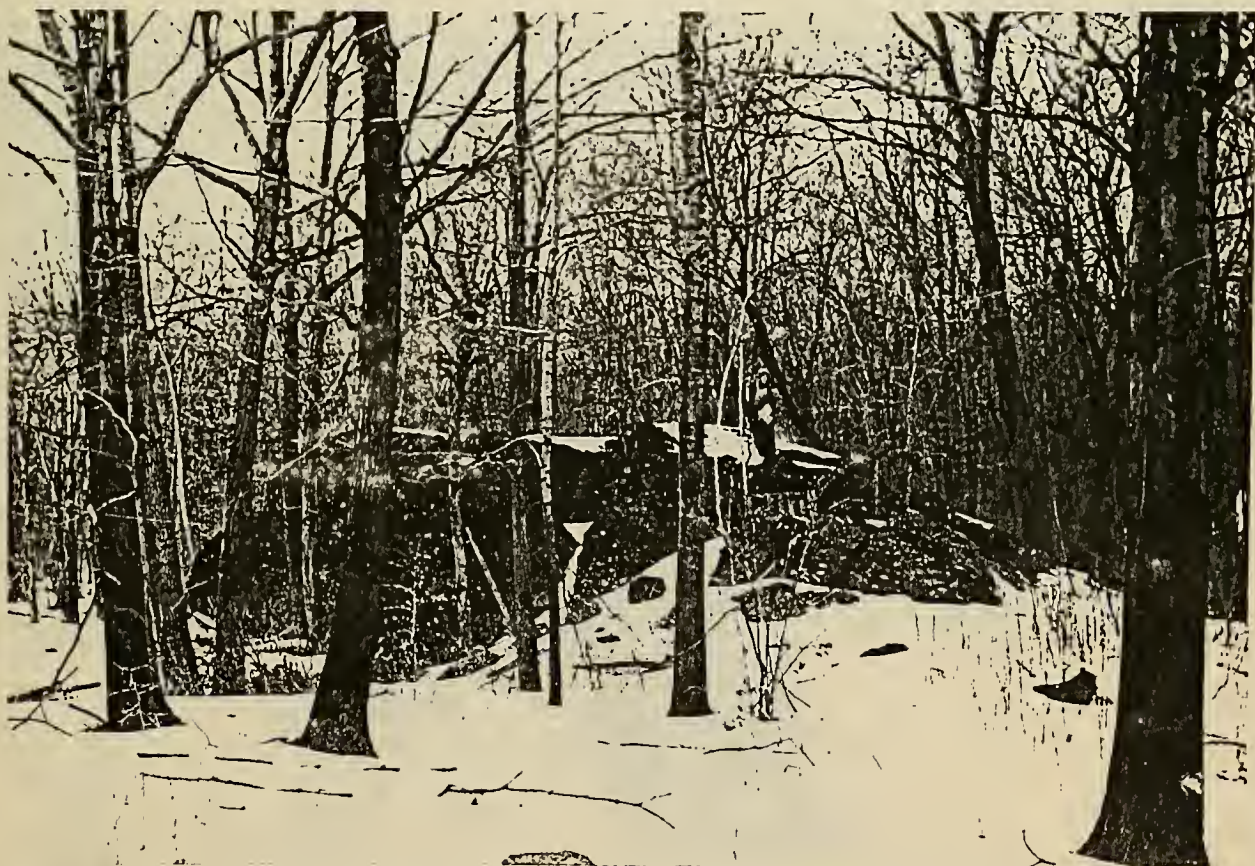
ROXBURY CONGLOMERATE - TYPICAL OUTCROP.

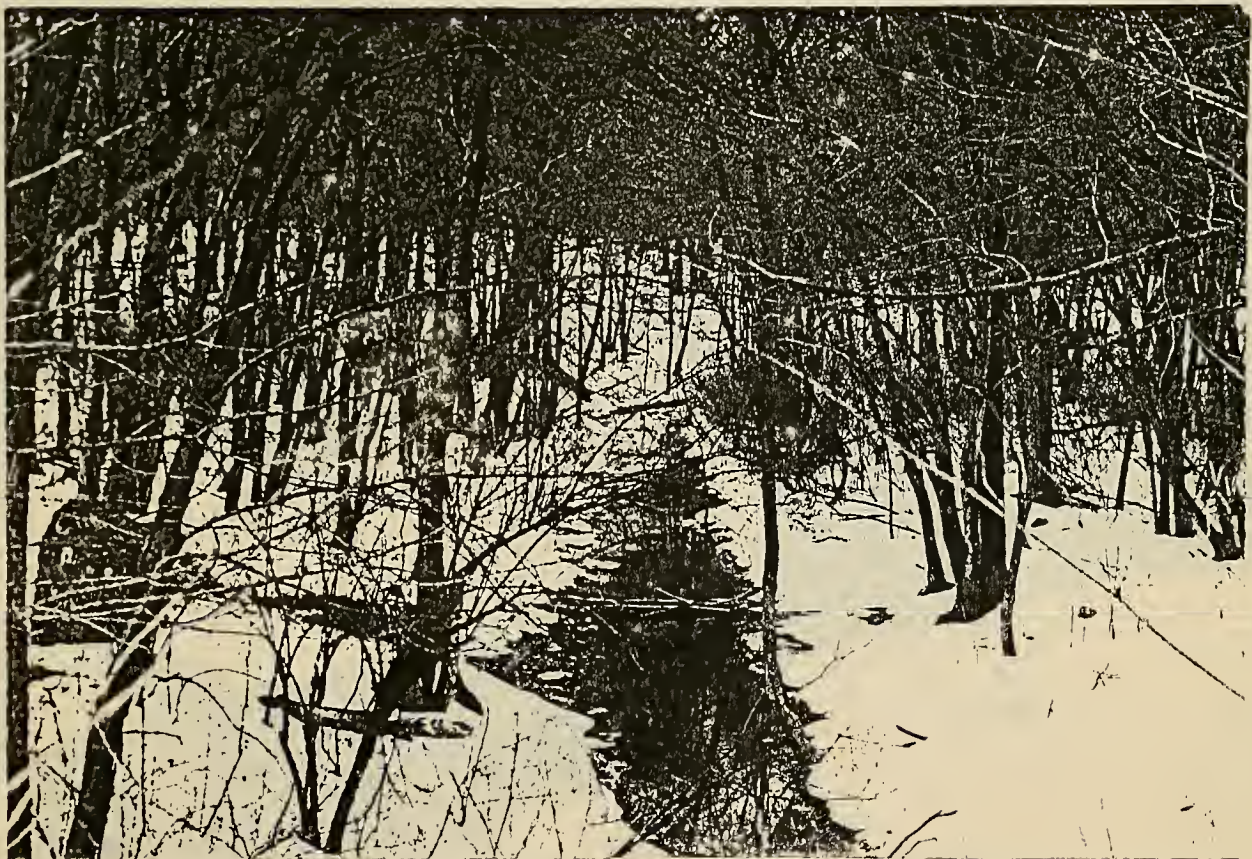
BROOK CHANNEL WHICH FLOWS EAST TO STORM DRAIN UNDER V.F.W. PARKWAY

Drainage -- Run-off from the eastern portion of Hancock Woods is channelized and directed to a storm sewer under V.F.W. Parkway which eventually empties into the Sawmill Brook at St. Joseph's Cemetery. The channelization is an attempt to lower the

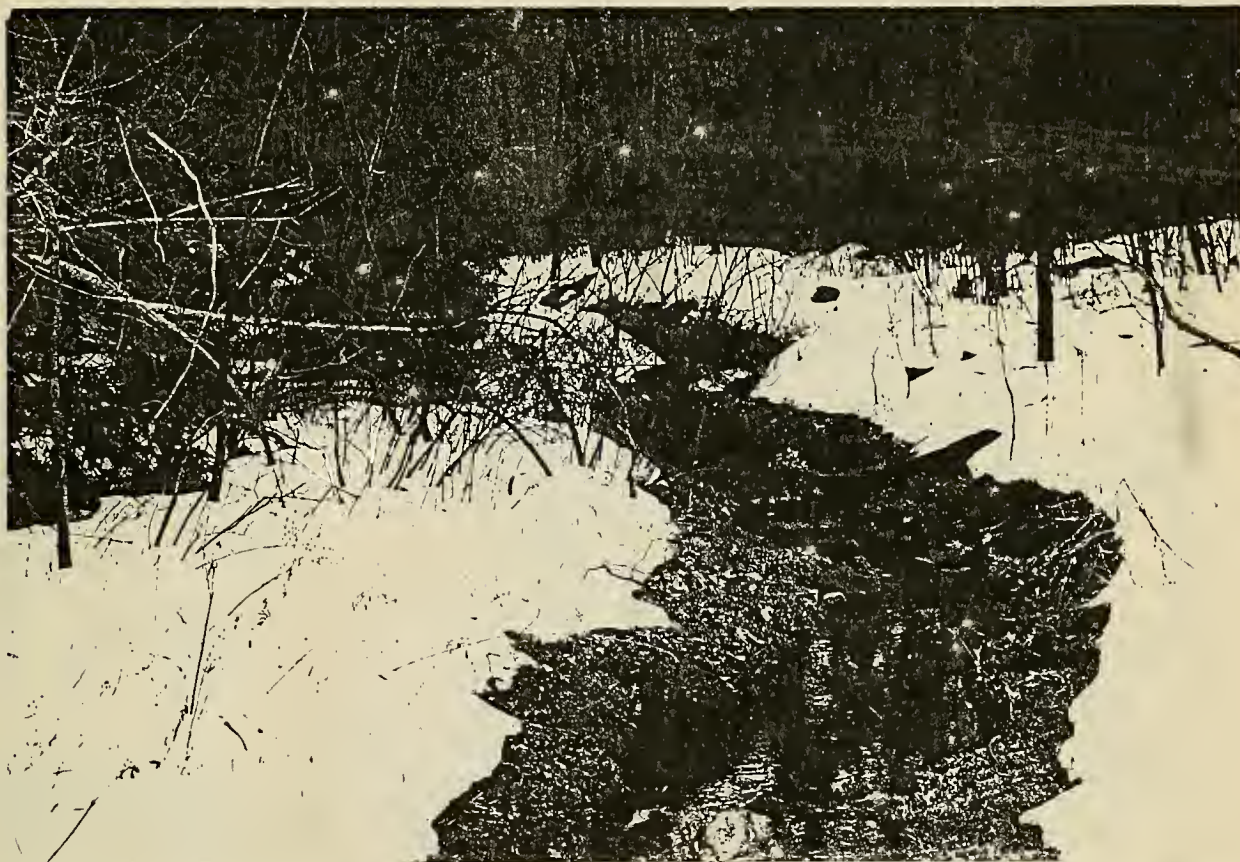
SAWMILL BROOK SOUTH BRANCH AS IT PASSES THROUGH BIRD SANCTUARY

water table, possibly initiated as a mosquito control measure. The western portion of Hancock Woods drains directly into the Sawmill Brook. The Hoar Bird Sanctuary contains the headwaters of what has been designated the south branch of the Sawmill Brook (see Location Map). In the bird sanctuary, small channels have been dug to aid drainage into the brook and to lower the water table, also preventing stagnation. After passing through a culvert at the northwest end of the fire road, the south branch of the Sawmill Brook enters Boston. At this point its channel has been altered. The old alignment is shown as a grey dashed line while a black dash-dot-dot-dot-line indicates the current brook. The realignment was done to facilitate construction of Broadlawn Park. The current brook is held as a sewage easement by the City of Boston.* After skirting Broadlawn Park, the brook passes into Newton where it joins the north branch and subsequently makes its way to the Charles River near Cow Island Pond. Except where it has been channelized by human action, the Sawmill Brook does not have a well formed channel and consequently has extensive wetland associated with it.
